ANNUAL REPORT FOR 2010

Unnamed Tributary to Howell Branch Wayne County
TIP No. R-2554BA – Site 5

Prepared By:
Roadside Environmental Unit & Natural Environment Unit
North Carolina Department of Transportation
October 2010

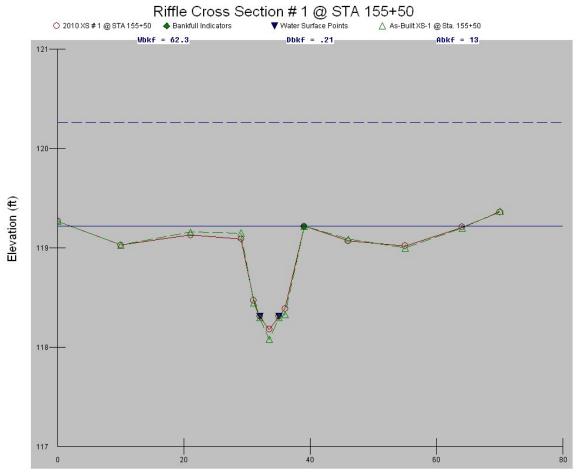
Based on comparisons of the as-built to 2010 monitoring data, all four cross sections appear stable with little or no active bank erosion. Graphs of the cross sections are presented in Appendix A. Future survey data will vary depending on actual location of rod placement and alignment; however this information should remain similar in appearance. The longitudinal profile shows that the channel is stable for the 2010 monitoring evaluation.

Cross-Section #1 (Riffle) Abbreviated Morphological Summary								
	2010	2011	2012	2013	2014			
Bankfull Width (ft)	10							
Bankfull Mean Depth (ft)	0.67							
Width/Depth Ratio	14.93							
Bankfull Cross Sectional Area (ft²)	6.75							
Maximum Bankfull Depth (ft)	1.04							
Width of the Floodprone Area (ft)	70							
Entrenchment Ratio	7

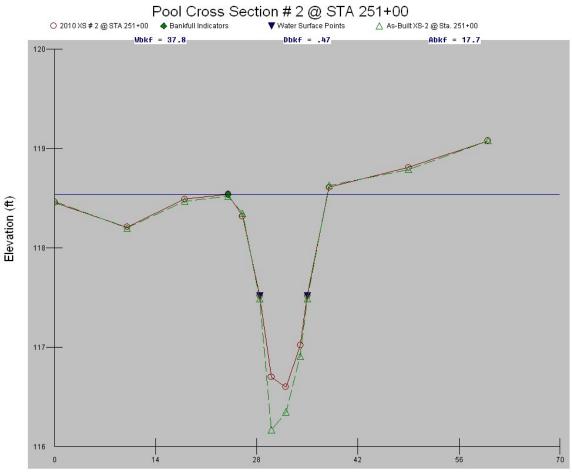
Cross-Section #2 (Pool) Abbreviated Morphological Summary*								
2010 2011 2012 2013 2								
Bankfull Cross Sectional Area (ft²)								
Maximum Bankfull Depth (ft)								
Bankfull Mean Depth (ft)	1.01							
Bankfull Width (ft)	13.81

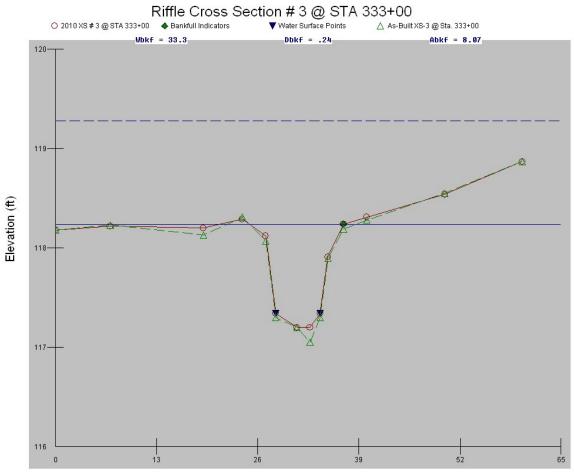
Cross-Section #3 (Riffle) Abbreviated Morphological Summary								
	2010	2011	2012	2013	2014			
Bankfull Width (ft)	12.12							
Bankfull Mean Depth (ft)	0.61							
Width/Depth Ratio	19.87							
Bankfull Cross Sectional Area (ft ²)	7.38							
Maximum Bankfull Depth (ft)	1.04							
Width of the Floodprone Area (ft)	60							
Entrenchment Ratio	4.95

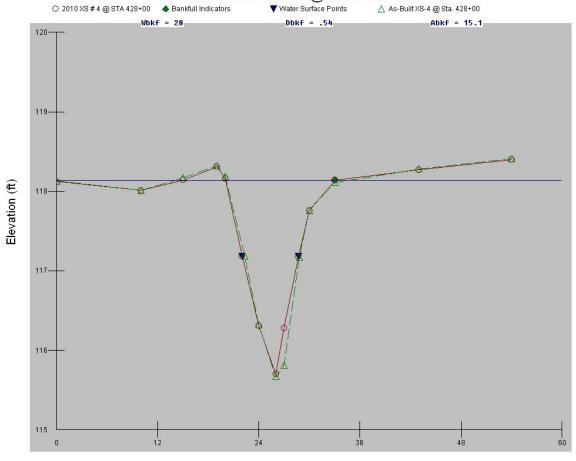
Pool Cross Section # 4 @ STA 428+00 ◆ Bankfull Indicators ▼ Water Surface Points △ As-Buil

Cross-Section #4 (Pool) Abbreviated Morphological Summary*								
2010 2011 2012 2013 20								
Bankfull Cross Sectional Area (ft²)	13.99							
Maximum Bankfull Depth (ft)								
Bankfull Mean Depth (ft)								
Bankfull Width (ft)

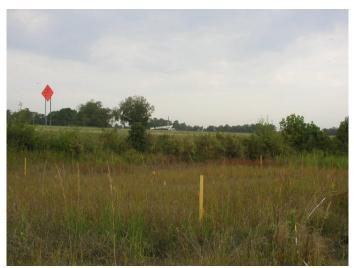
Vegetation Plot #1 taken from PP#1

Plot#	ಲ Tulip Poplar	American Sycamore	Black Walnut	ω River Birch	Total (Year 1)	Total (at planting)	Density (Trees/Acre)	
1 2	3	7	1	3	14	37	257	
2	1	4		11	16	37	294	
Average Density (Trees/Acre) 276

There were two vegetation monitoring plots established throughout the buffer area. The 2010 vegetation monitoring of the site revealed an average tree density of 276 trees per acre. This average is below the minimum success criteria of 320 trees per acre after year one monitoring. NCDOT is planning to replant the site by March 2011. NCDOT will continue to monitor the vegetation at the UT to Howell Branch Mitigation Site.
